The 2003 San Simeon Earthquake

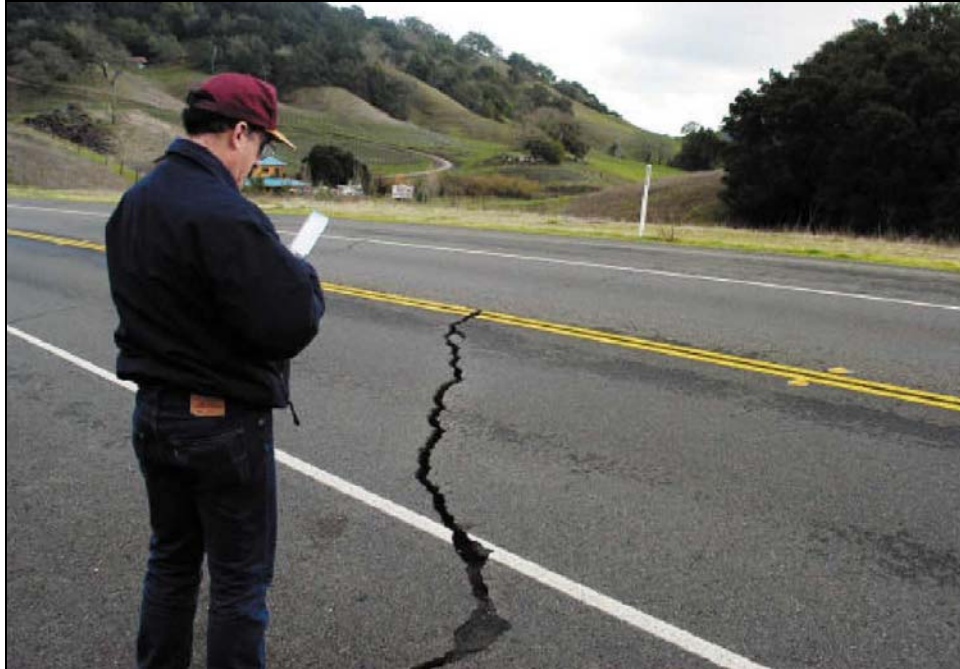
The most significant road damage was at State Routes 41 and 46 between US-101 and SR-1 (Figures 7.2 and 7.3). Ron Richman, the District 5 geotechnical engineer writes, *"We observed rockfalls originating from cut slopes on State Route 41. The Route 46 damage included surging of landslides, spreading of tall embankments and fissuring at*

the contacts between the original ground and tall embankments. We did not observe significant effects on the bridges in the region. We looked for indications of liquefaction, but found none.” This damage was sufficient to keep Caltrans’ road crews busy with traffic control and roadway repairs for several weeks after the earthquake.

Fig. 7.3. Cracks in State Highway 4

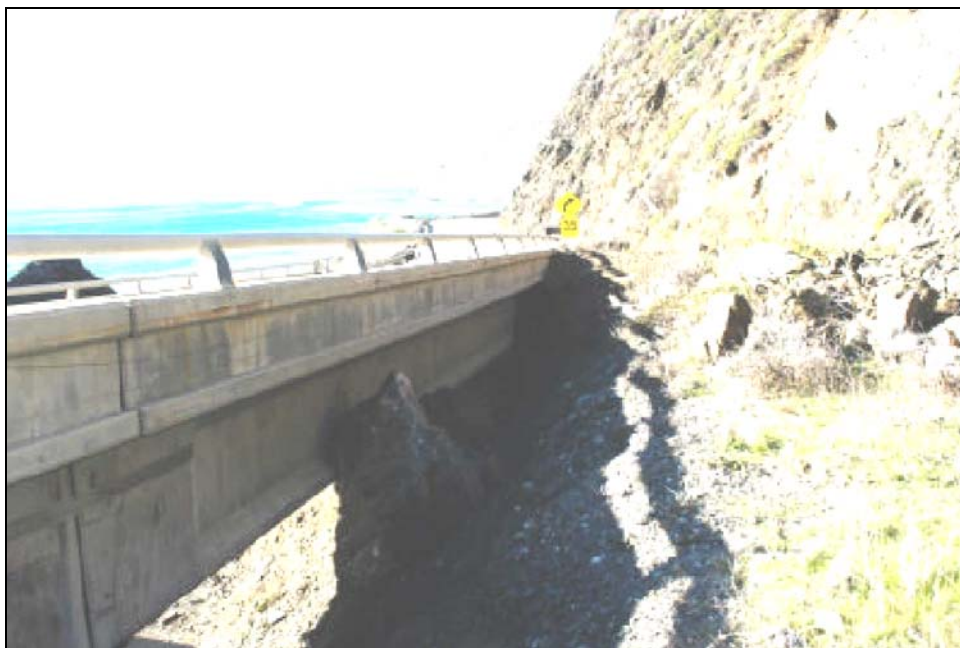
Villa Creek Bridge, 11 km (7 miles) north of San Luis Obispo County, was the only Caltrans structure that was damaged during the earthquake (Figure 7.4). This is a five simple-span, precast girder structure on State Highway 1, along the Pacific Coast. The deck is supported on tall single column bents. The bridge was recently retrofit, which didn't protect it from a rockslide that put a hole in the northeast girder web (Figure 7.5). However, this damage did not reduce the girder's ability to carry traffic and the bridge remained open following the earthquake.

Fig. 7.4. Villa Creek Bridge

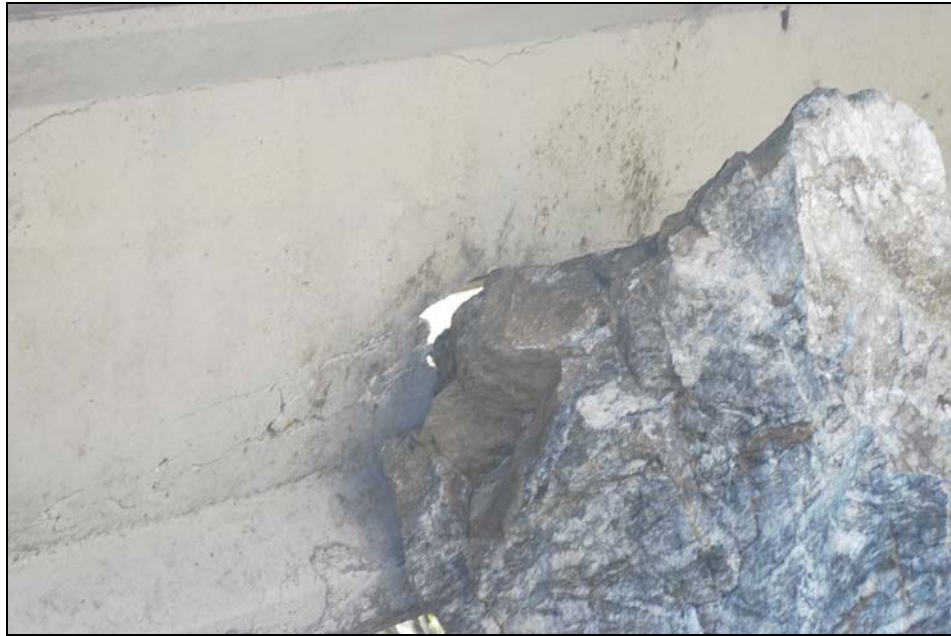
Fig. 7.5. Villa Creek Bridge Damage

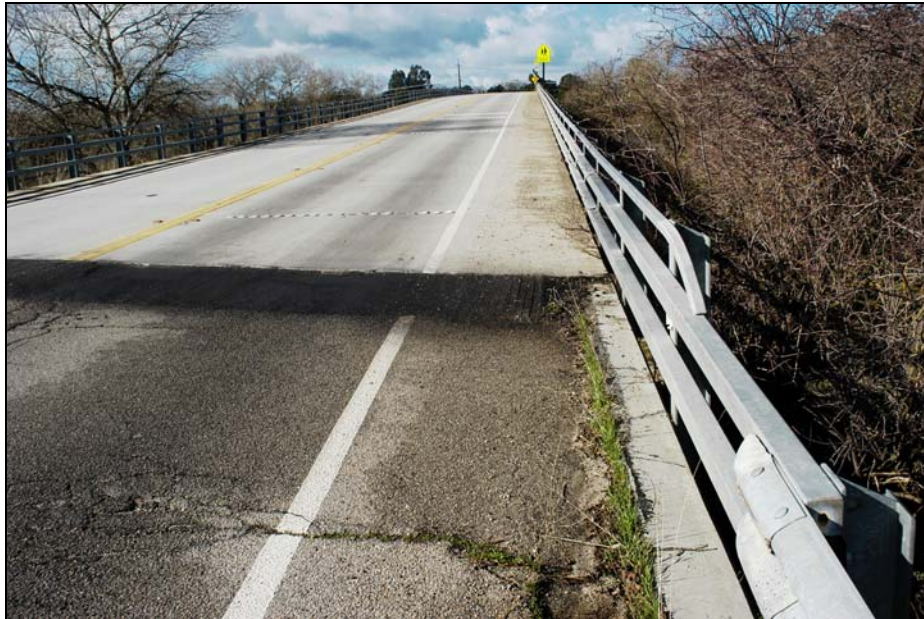
The Templeton Road Bridge spans over the Union Pacific Railroad and the Salinas River. The west two spans are cast-in-place (CIP) girders and the east five spans are reinforced concrete box girders. The superstructure is on flared, single column bents with piles and on seat and end diaphragm abutments on spread footings. The bridge was not retrofit. Most of the damage was due to liquefaction, settlement, and shaking of the superstructure. The approaches settled about 5 inches (12.5 centimeters) and the barrier rail was damaged (Figure 7.6). The conduits under the bridge for utility lines (Figure 7.7) were also damaged. Soil borings were taken before asphalt was placed to repair the approaches.

Fig. 7.6. Approach Settlement and Barrier Rail Damage

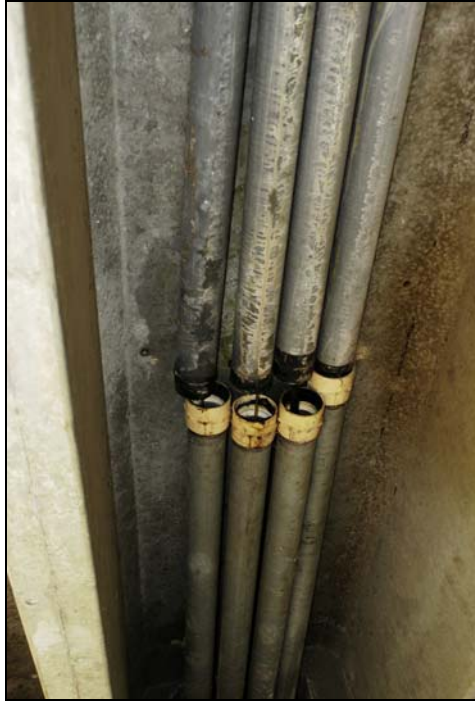
Fig. 7.7. Broken Conduits Under Bridge

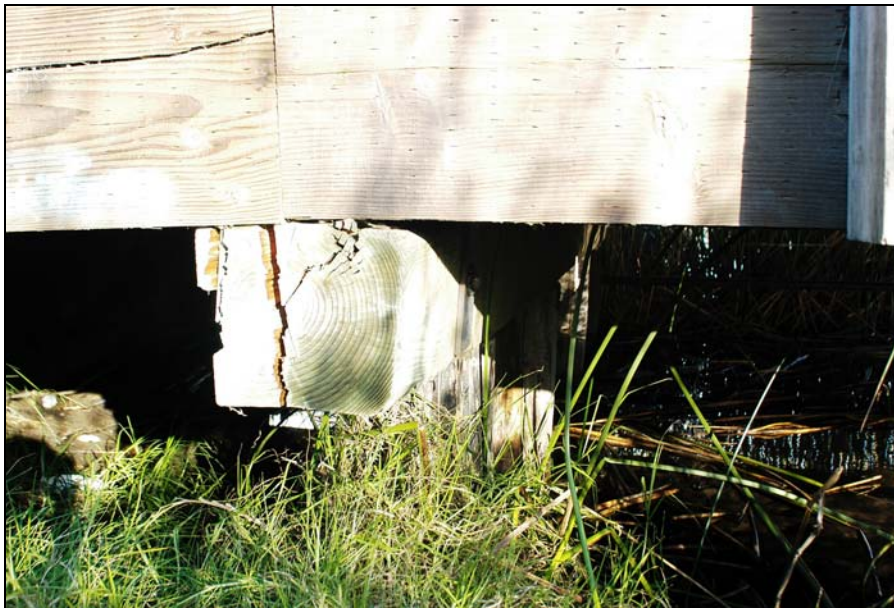
A saltwater lagoon in Oceano frequently floods its banks. This part of town was built on the loose, saturated alluvium carried by these floods. This soil liquefied during the earthquake causing considerable damage. There are three timber trestle bridges that cross over the lagoon and they were all damaged due to lateral spreading. The seat-type abutments moved toward the lagoon cracking the timber stringers and splitting the timber bent caps (Figure 7.8). These bridges look fairly new and the lumber appears to have been recently purchased.

Fig. 7.8. Broken Bridge Timbers.
